Graphical Analysis of B-737 Airplane Pathloss Data for GPS and Evaluation of Coupling Mitigation Techniques

Abstract— The use of Portable Electronic Devices (PEDs) onboard commercial airliners is considered to be desirable for many passengers. However, the possibility of Electromagnetic Interference (EMI) caused by these devices may affect flight safety. PEDs may act as transmitters, both intentional and unintentional, and their signals may be detected by the various navigation and communication radios onboard the aircraft. Interference Pathloss (IPL) is defined as the measurement of the radiated field coupling between passenger cabin locations and aircraft communication and navigation receivers, via their antennas.

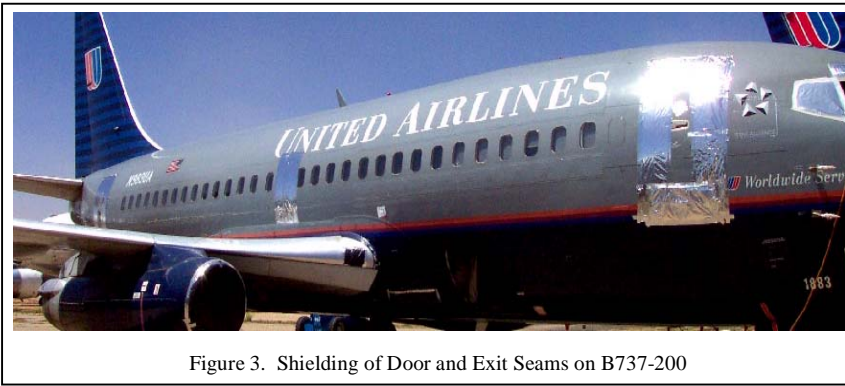
Figure 3. Shielding of Door and Exit Seams on B737-200

“Aircraft taping” required conductive sealing of all door and exit seams on both sides of the aircraft using heavy-duty aluminum foil and adhesive-backed aluminum tape (as shown in Figure 3).

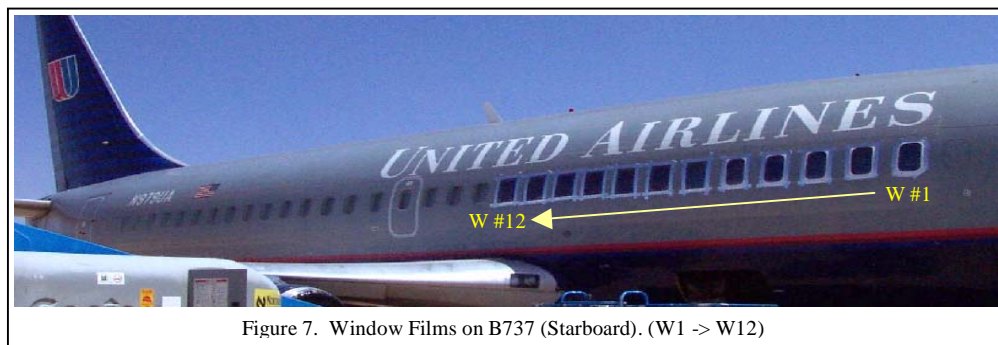
Figure 7. Window Films on B737 (Starboard). (W1 -> W12)

Figure 7 shows another kind of shielding technique used for IPL measurements by taping electrically conductive window films from windows #1 to #12 on the starboard (right) side of B737-200 (#1879). The particular film used was Cortaulds VS-60 “spectrally selective” film, having a high visible light transmittance (58%), and high silver content. The film sample was obtained from the manufacturer (CPFilms), in 1998. No surface resistance data was available for the VS-60 film at the time of this analysis, but since 1998, new films with higher visible light transmittance have been introduced specifically for EMI shielding applications. [5] In this case, the film was temporarily bonded to the aircraft using 2”-wide aluminum tape. IPL measurements were performed with and without the film installed.

B. Analysis of Window Films on TCAS
